Date of Scan: 7/2/08

Images provided: Cone Beam CT images in the bone window. Axial, coronal and sagittal views.

- Please look teeth #1-6 for implant placement.

1. Implant Planned
2. Rule Out Pathology

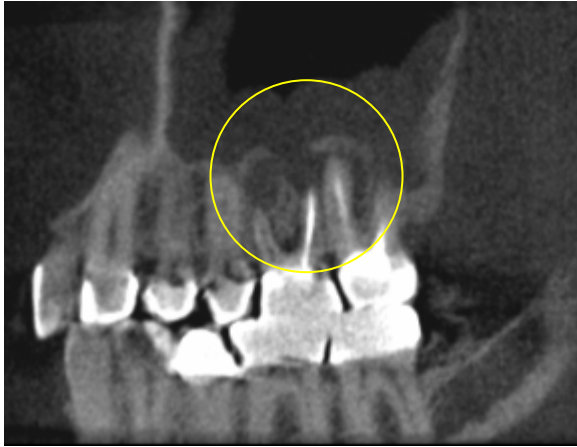
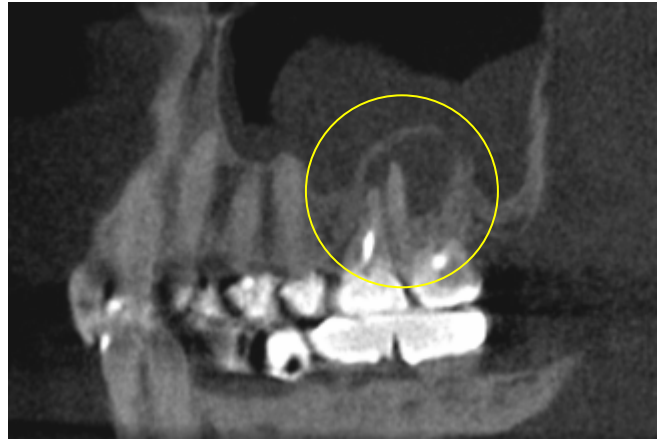
Low densities are noted at the apices of teeth #14 and 15, the lesions appear to be extending toward the maxillary sinus with superior expansion and interruption of the, thickened, floor of the sinus.

Left maxilla showing periapical cyst or granulomas at teeth #14 and 15

- Restorative and surgical evaluation for teeth #14 and 15 is suggested.
- Referral to ENT for sinus evaluation is suggested if dental treatment is not definitive.
- Periodontal evaluation is suggested for tooth #5.
- The measurements included in this report are to give the dentist a general idea of the amount and architecture of the remaining alveolar bone. ***Please perform your own exact measurements during treatment planning.***
